PHASE I INSPECTION REPORT
NATIONAL DAM SAFETY PROGRAM

**BOX ELDER CREEK DAM
PLENTYWOOD, MONTANA
SHERIDAN COUNTY
MT-934**

PREPARED BY:
CH2M HILL
BELLEVUE, WASHINGTON
DECEMBER 1980

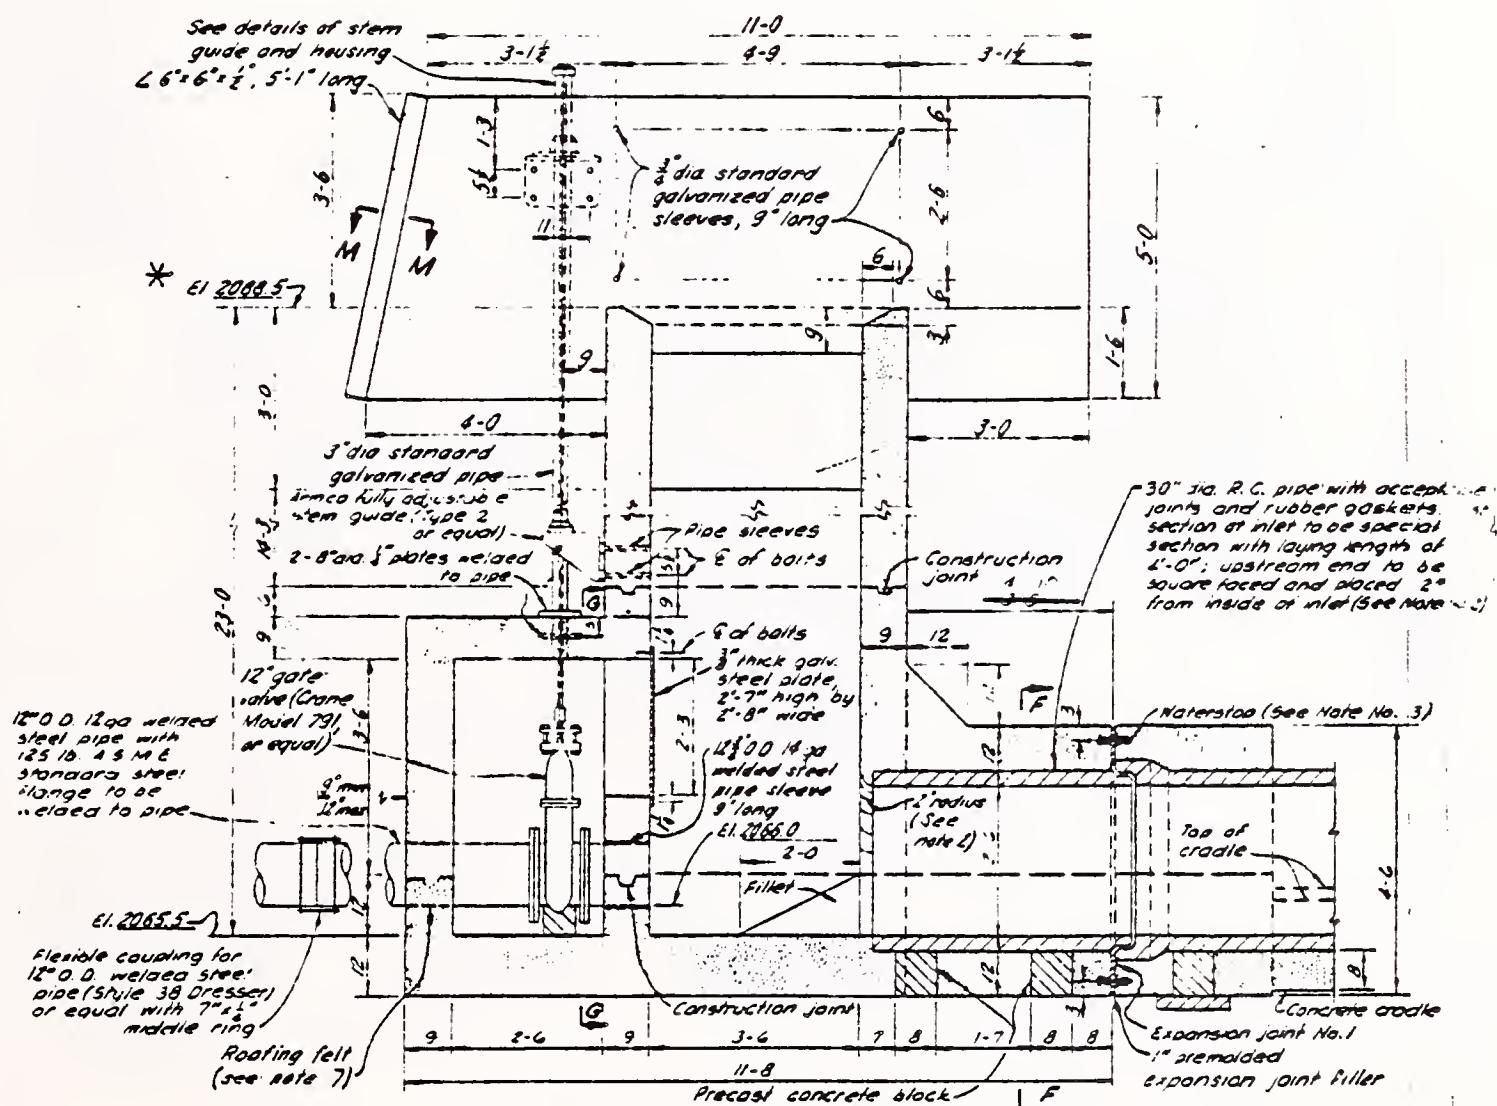
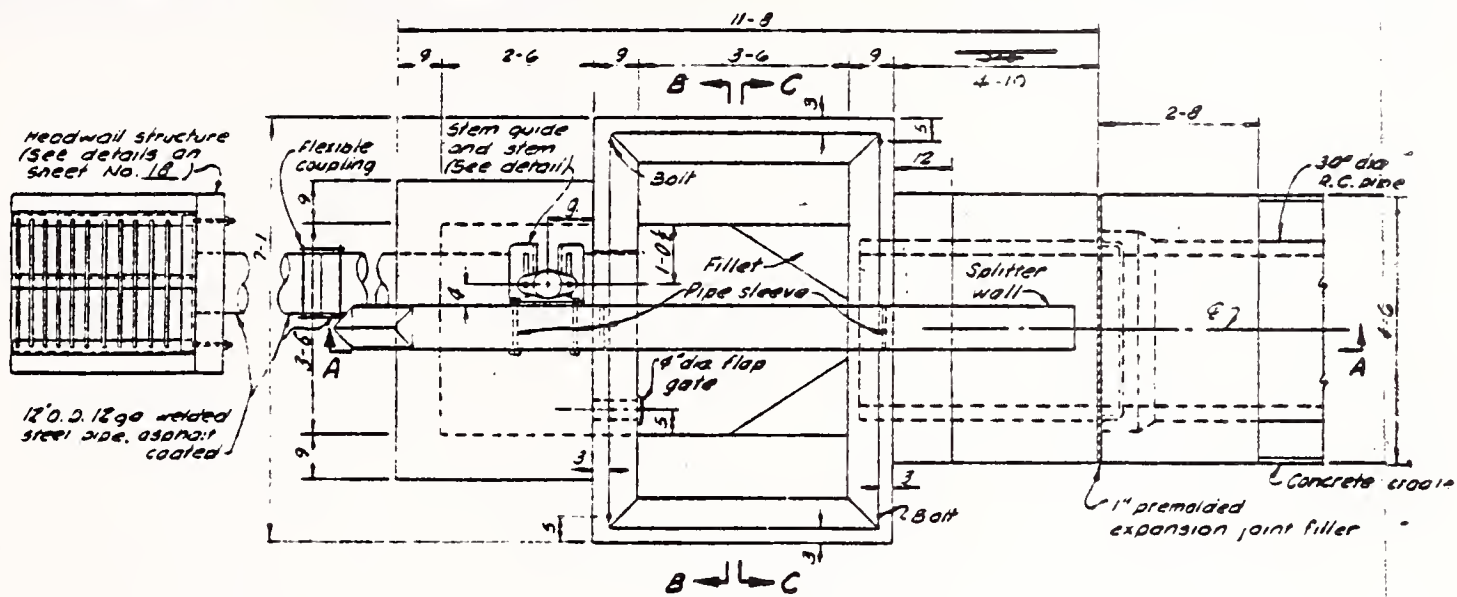
PLATE 5
BOX ELDER CREEK DAM
PRINCIPAL SPILLWAY INLET
PLAN AND SECTION

* CREST ELEVATION OF
SPILLWAY RAISED 2 FT.
IN 1975

and make any necessary repairs. The area at the bottom of the riser is subject to falling water and could be experiencing erosion; therefore, particular attention should be given to this area during the inspection. Conduct more detailed hydrologic and hydraulic routing studies to better determine the downstream hazard and required spillway capacity and modify the project as studies indicate. Study discharge characteristics of the emergency spillways and implement modifications to the west spillway channel to protect embankment from erosion during spillway discharges. Conduct periodic inspections of the project at no less than 5-year intervals by engineers experienced in dam design and construction. Prior to performing engineering studies and remedial work coordinate with the Montana DNRC to ensure compliance with all pertinent laws and regulations.

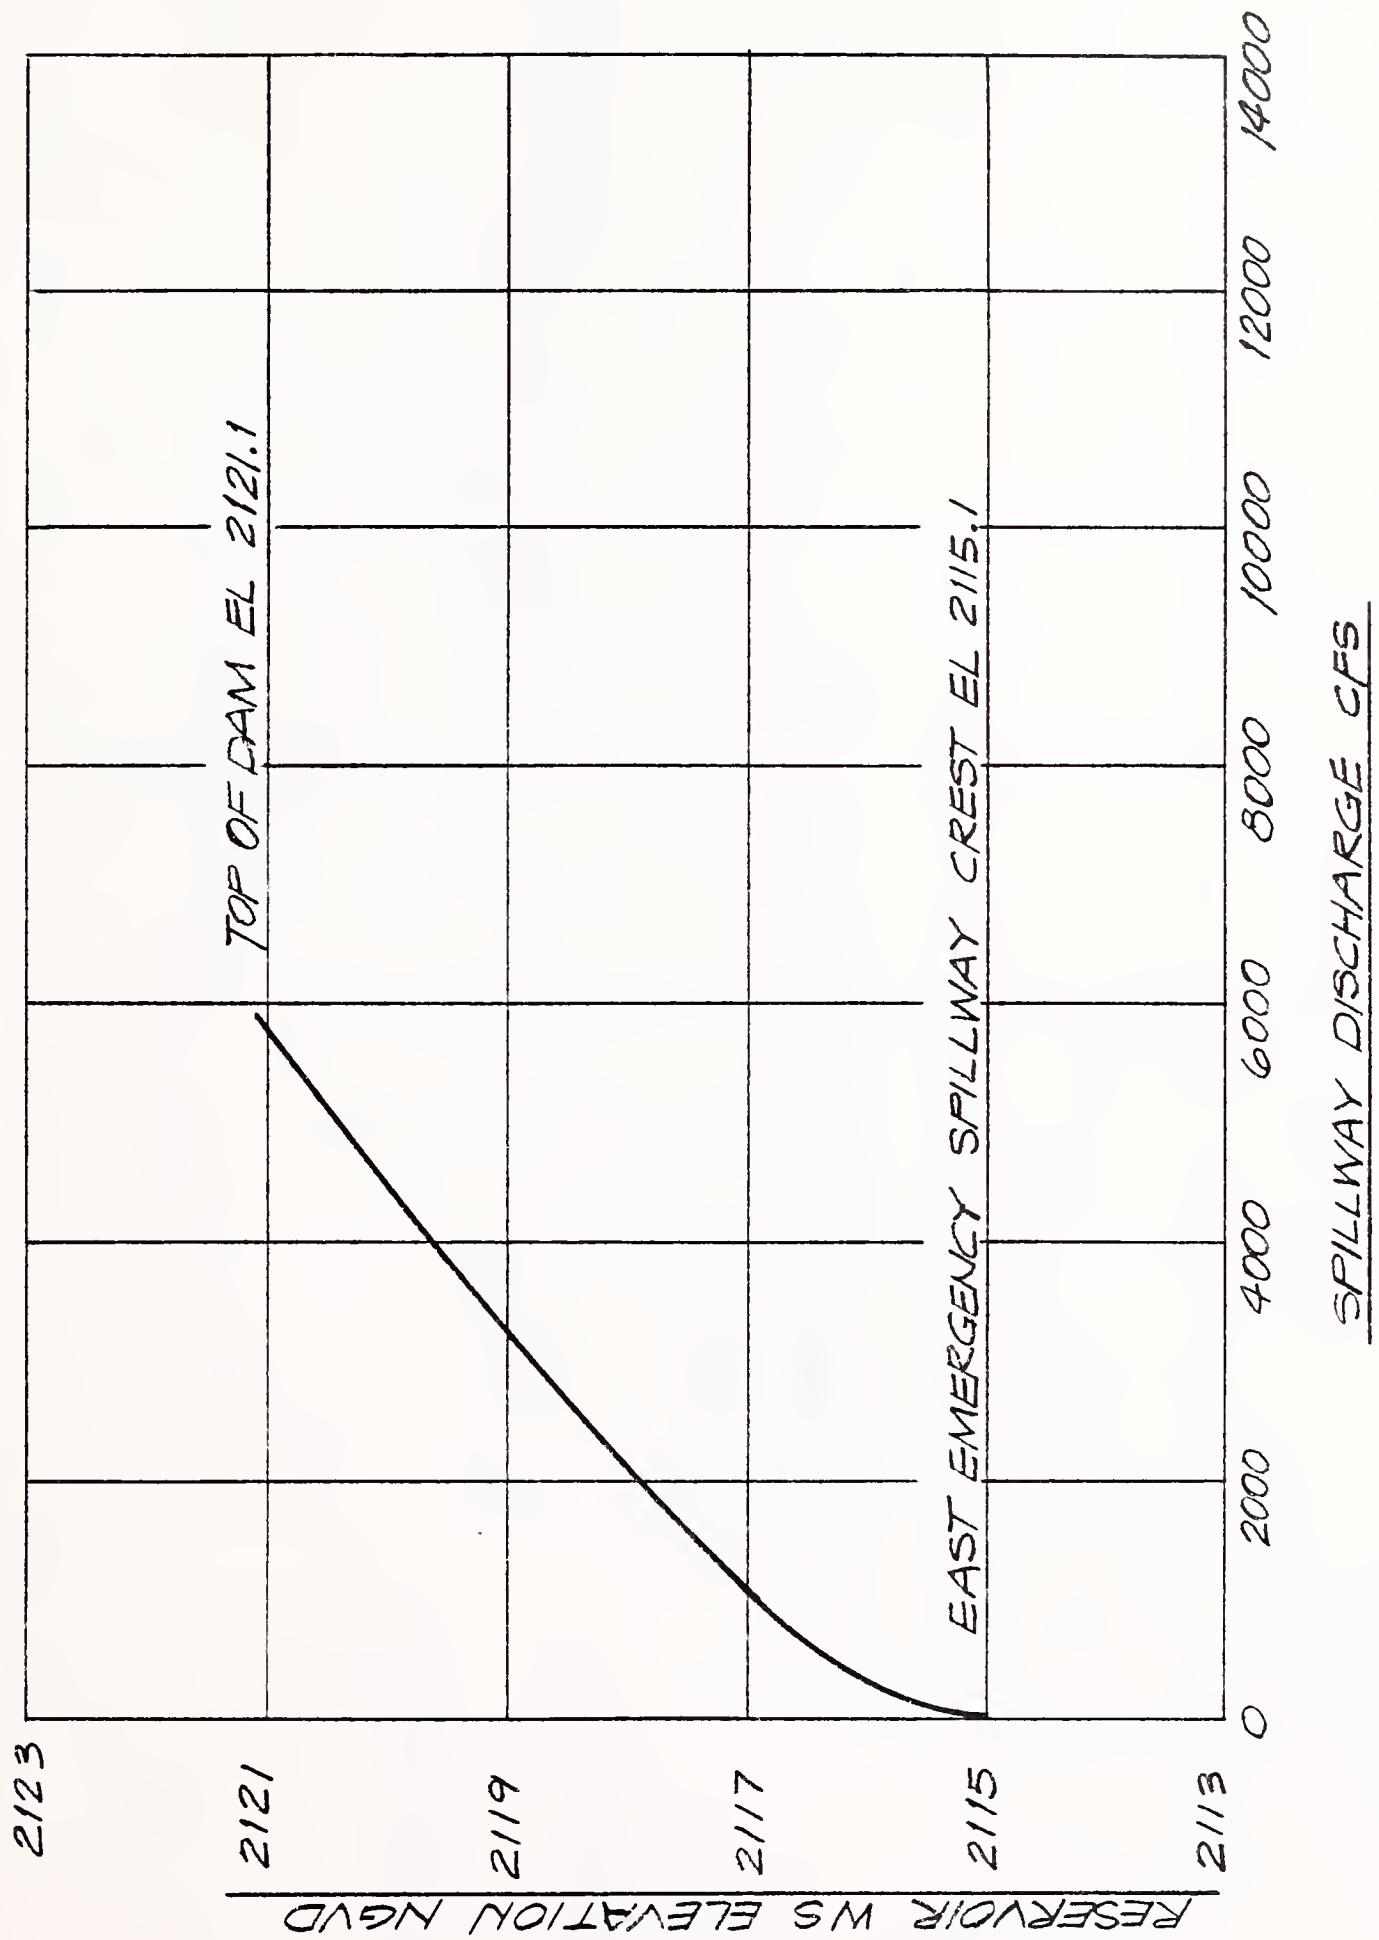
PLATE 9
 BOX ELDER CREEK DAM
 EAST EMERGENCY
 SPILLWAY RATING CURVE

The discharge rating curve (Plate 9) for the east emergency spillway was developed by assuming that critical depth occurs at the control section and by computing backwater effects in the approach channel between the reservoir and the spillway crest. A Manning's "n" of 0.03 was used. The maximum discharge capacity of the east emergency spillway with the reservoir at top of dam, elevation 2121.1 feet NGVD, is 5,950 c.f.s.

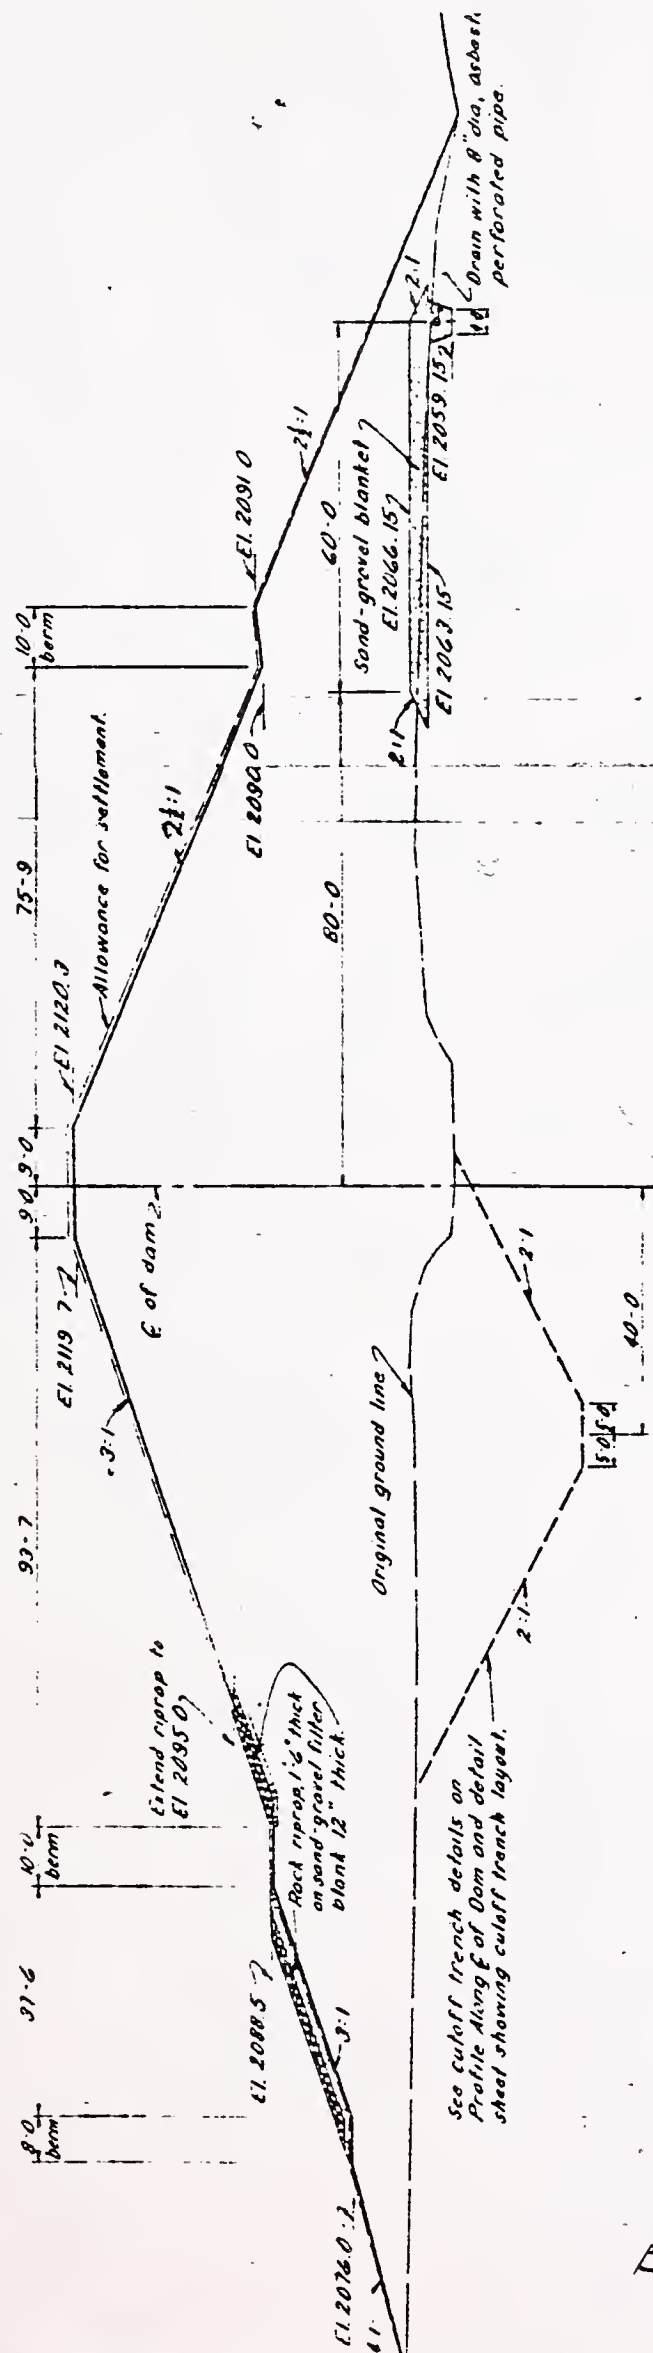
PLATE 10
BOX ELDER CREEK DAM
DAM EMBANKMENT
SECTION

The 60-foot-high, straight-axis homogeneous earthfill embankment is 1,800 feet long and has a crest width of 18 feet. The upstream slope is 1 V on 4 H from the toe up to elevation 2076.0. Above this level the slope is 1 V on 3 H with a 10-foot-wide bench 20 feet above the toe (Plate 10). The downstream slope is 1 V on 2.5 H with a 10-foot-wide bench 30 feet above the toe.

The October 30, 1979 inspection found the embankment material to be a clayey, sandy silt. These embankment materials could quickly erode and rapidly fail when overtopped by floodwaters. The "Watershed Work Plan" (Ref. 3) identified overburden soils as 1 to 5 percent gravel, 20 to 25 percent sand, 24 to 33 percent clay, and 40 to 50 percent silt. The upstream slope (Photo 5) below elevation 2095 is adequately covered with grass and an 18-inch layer of riprap on a 12-inch sand and gravel blanket, and the downstream slope (Photo 6) is covered by grass. No significant erosion, irregularities, slumps, or cracks were found on the dam crest or slopes.
